WEST HILL ROAD, WEST HILL, DEVON

FOOTWAY ACCESS TO VILLAGE HALL

Stage 3 Road Safety Audit

TJS-DS-25-4713-RSA3

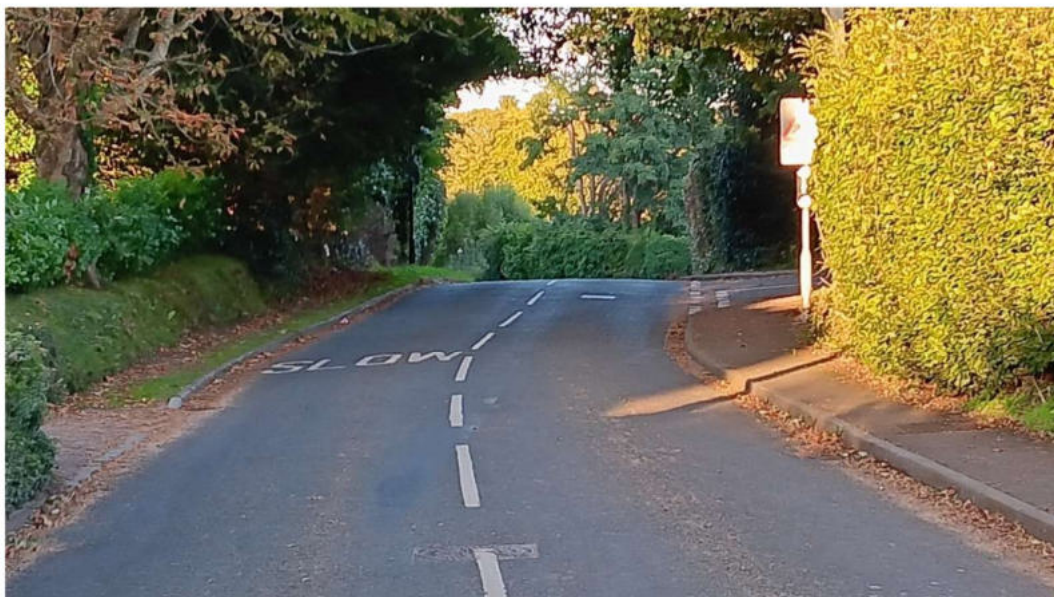
The existing Wig-Wag warning sign on West Hill Road has been re-located so that it is now to the west of, and in advance of, the uncontrolled crossing. However, the forward sightline to it is obstructed to some extent by a hedgerow immediately to the west. This lessens the effectiveness of the sign and therefore increases the risk of pedestrians being hit by passing vehicles. The photograph below is taken from the point at which the wig-wag becomes visible.

It is recognised that vehicle speeds are constrained by traffic calming and the alignment of the road and that this reduces the necessary forward visibility. However, the sign is likely to become more seriously obscured by hedge growth.

It is recommended that the Wig-Wag sign is relocated such that it will not be obscured by the hedgerow. For example, it may be possible for it to be mounted on the nearside post along with the existing solar-powered vehicle actuated signage, or possibly to the eastern side of Warren Park, closer to the carriageway. A further alternative might be to cut back the hedgerow and ensure that it is cut regularly in order to maintain the sightline.

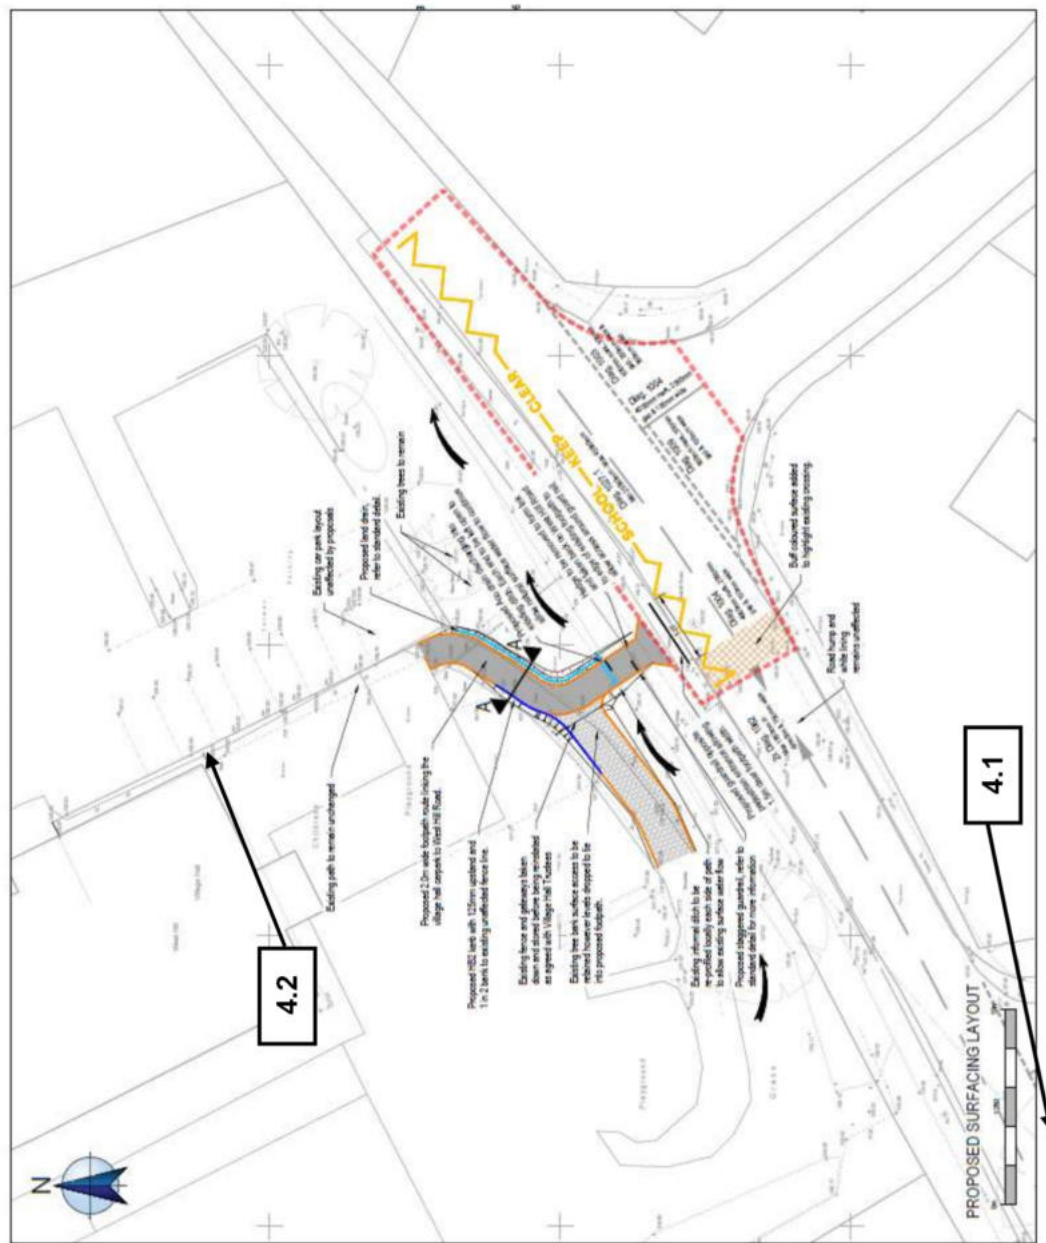
APPENDIX A: LOCATION PLAN

- 1.11 All problems identified in this Road Safety Audit Report are indicated on a location plan in Appendix A
