ARBORICULTURAL REPORT

Site Address	Village Hall, Beech Park, West Hill, EX11 1UQ
Client	West Hill Parish Council
Prepared By	Matthew Shute, FdSc Arboriculture, M.Arbor.A East Devon Tree Care Ltd Arboricultural Contractors and Consultants
Report Reference	WEST-210429.0 - Arboricultural Report at West Hill Village Hall
Version No	1
Date Issued	30.04.21

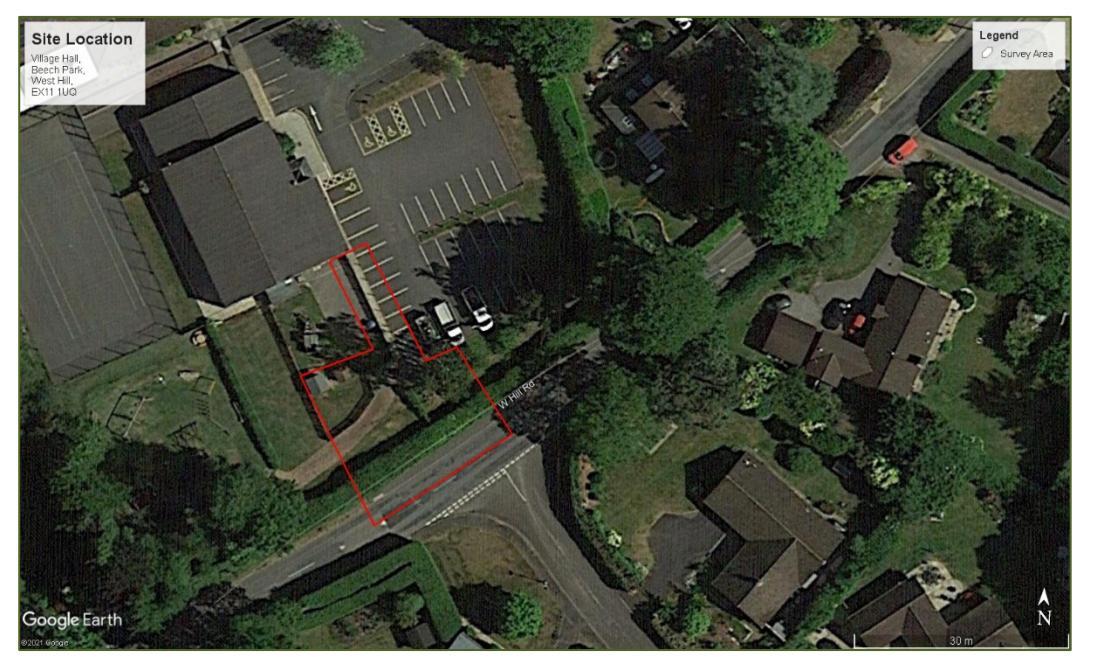
IMG 1: Site location

4.1 The surveyed area is a small area of land located to the south of West Hill Village Hall, between the car park and the play area. The extent of the survey area is shown as the red polygon on the plan below.

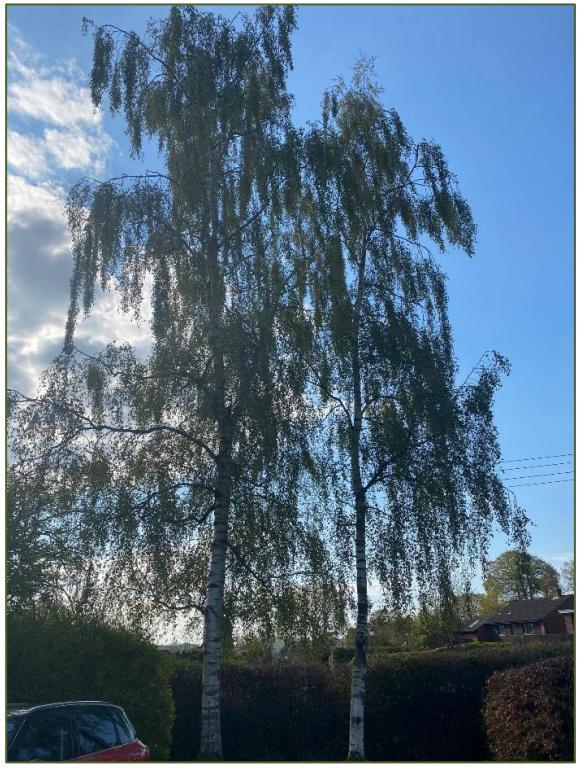
IMG 2: Overview of trees. T1 on the left.

- 5.4 **Category B Trees.** Trees of moderate value, including those that do not qualify as category A due to impaired condition and/or those that collectively have higher value than they would as individuals; also trees with material conservation or other value. The design of the proposed development, where feasibly possible, should take into account the retention of category B trees. A design layout that suggests the removal of category B trees has an increased risk of planning refusal.
 - 5.4.1 Both inspected trees are Silver Birch (Betula pendula) on a narrow strip of grass to the south of the car park. Both trees are in good condition physiological and structural condition.

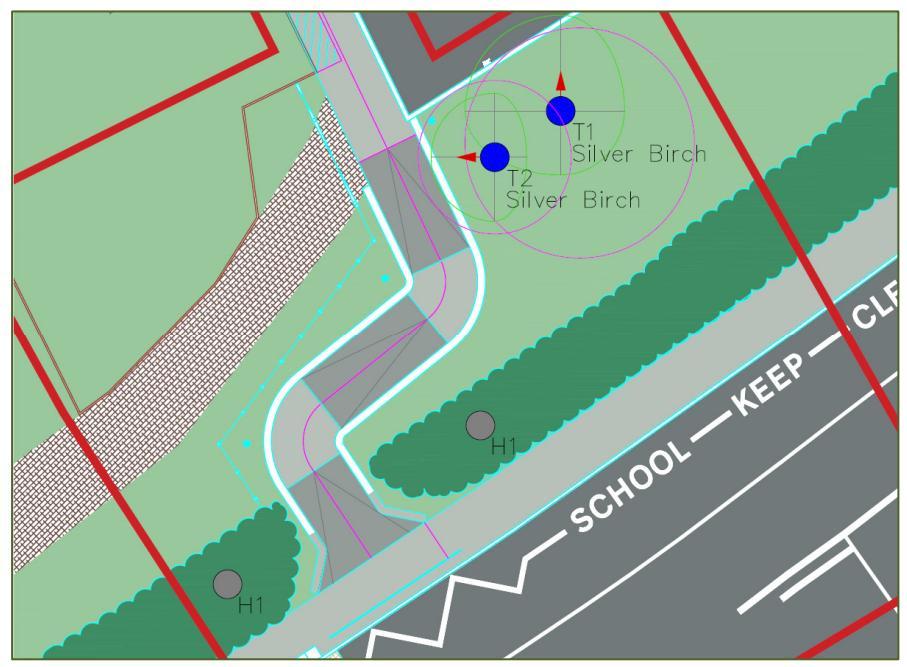
IMG 3: Proposed footpath

8.1.1 The development proposal is the construction of a pedestrian entrance between West Hill Road improving access to the village hall and the school. It will involve the creation of a path and the removal of a short length of the hedge bank within H1.

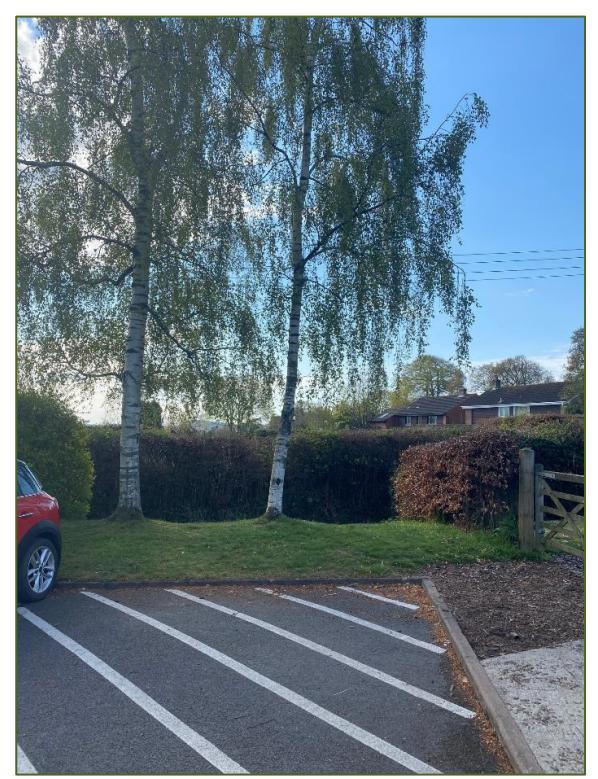
IMG 4: Raised grass area in route of proposed path.

8.2.1 The grassed areas where these trees are growing, forms a slight hump above the car park. This raised ground will need to be lowered to allow the construction of a new footpath with a gentle slope down to the road.

- 8.2.2 The lowering of the ground level and construction of the proposed path will make an incurrence of 700mm into one side of the 2.4m radius RPA of T2. RPAs are calculated to be the minimum size area of undisturbed ground that a tree needs to support a viable rooting area.

- 8.2.4 By making an incurrence of 700mm into the RPA, and lowering the grass hump, it is likely that tree roots will be severed. This severance will occur approximately 1.2m from the stem. I do not think that the severance of these roots will cause instability of the tree in the short term but could result in inducing dysfunction in the tree and reducing its longevity.

- 8.2.5 The path, in its current form, could be constructed without felling the tree, but the severance of its roots cannot be avoided. If the Parish Council wish to retain the tree, then a trench will need to be hand dug or excavated with an air spade to allow tree roots to be pruned prior to any mechanical excavations. This scenario allows retention of the tree in the short term, but periodic monitoring will need to be made to ensure the effects of the root severance do not cause dysfunction which may elevate the risk of the tree failing.

- 8.2.6 Removal of T2 would be a reasonable alternative to root pruning and any monitoring of the tree for dysfunction. If the Parish Council would prefer this option, then it is recommended that an agreement is made to plant at least two replacement trees on the site and secured by a condition of planning.

8.3.1 The proposed footpath passes beneath the canopy of T1, which is currently as low as 2m above the car park. If T2 is retained, pruning to increase canopy clearance to 4m above the path will be necessary.
